Emergency Water and Weatherproofing System

Belzona 3121 (MR7) is a two component emergency repair and weatherproofing system for the sealing of almost all types of roof surfaces and structures, even during adverse weather conditions. This liquid-applied material is designed for instant waterproofing and can be applied in year-round weather conditions.

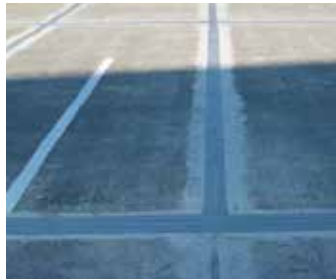
Expansion joints

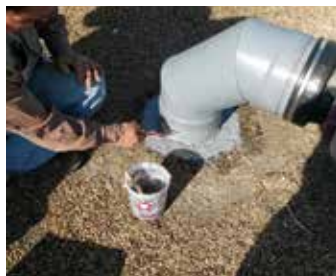
Vents
